BEHAVIOR OF A LANDSLIDE PRIOR TO INDUCING A VIADUCT FAILURE, CARACAS-LA GUAIRA HIGHWAY, VENEZUELA.

Daniel A. Salcedo
Professor Central University of Venezuela
Consulting engineer

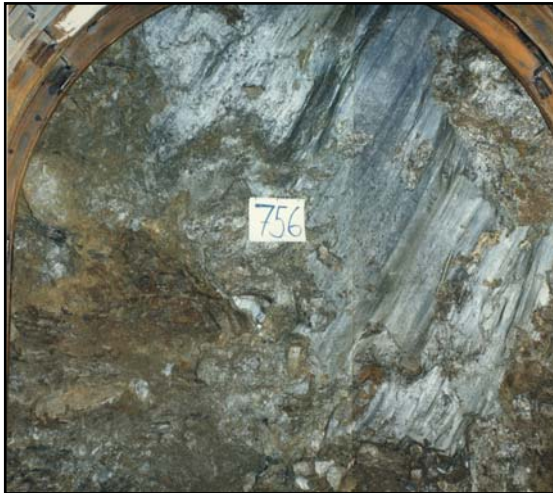
Figure 4. Polished striated surfaces (slickenside), inside the fault breccia found in the exploratory adits. Width of exploratory adit was 2.9 m.

- The existence of a fault breccia with a length of 50 m measured in the direction of one of the main galleries, which was excavated parallel to the displacement vector of the landslide. It was possible to differentiate at least three periods of tectonism. The first period characterized by petrified slickensides, probably contemporary with the fault age, and the second and third period characterized by polished clays with slickensides of recent appearance which according to the writer can be assigned to recent tectonic processes (neotectonic). Figures 4 and 5 show recent slickensides (striated and polished surfaces) found during excavation. Two generations of slickensides were also observed in a scanning electron microscope.

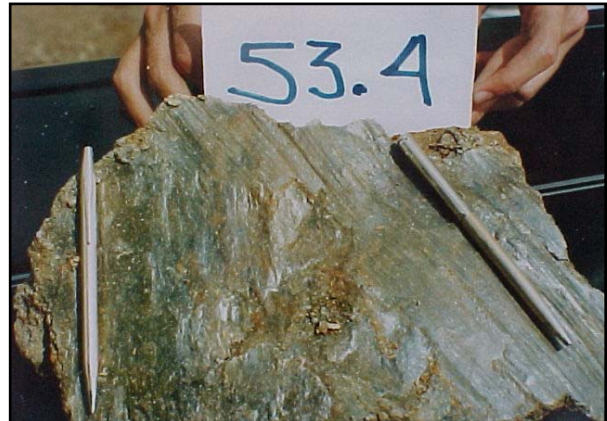
Figure 5. Two generations of polished surfaces and slickensides in a sample taken inside the exploratory adits.

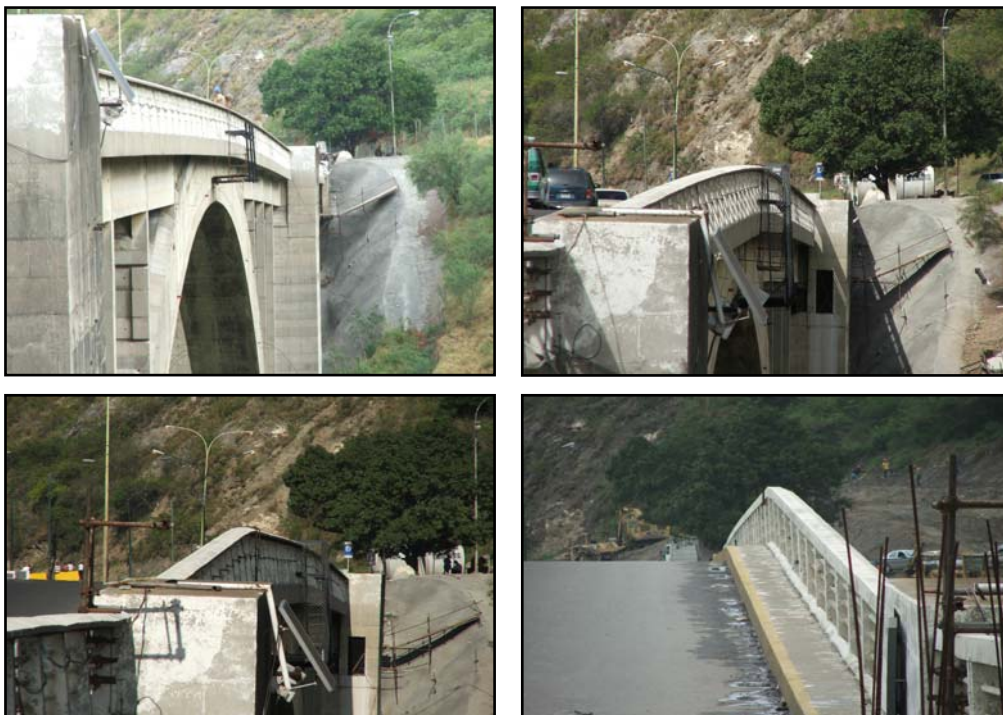
Figures 11a, 11b and 11c. Comparative views of deck deformation at different dates (August, 2005, December 2005, and January 5, 2005). Figure 11d: Closed view of deck vertical deformation which had reached 130 cm at the crown and 167 cm at the ruptured section; picture taken from the Caracas pilaster in March 9, 2006.

Geodetic measurements revealed that at the end of November 2005, with most of the rehabilitation measures completed, the vertical deformation of the crown was 90 cm, and at the end of December 2005, this deformation reached 115 cm. Figures 11(a) to 11(d) show vertical deformation of the crown due to arch closing at different dates.

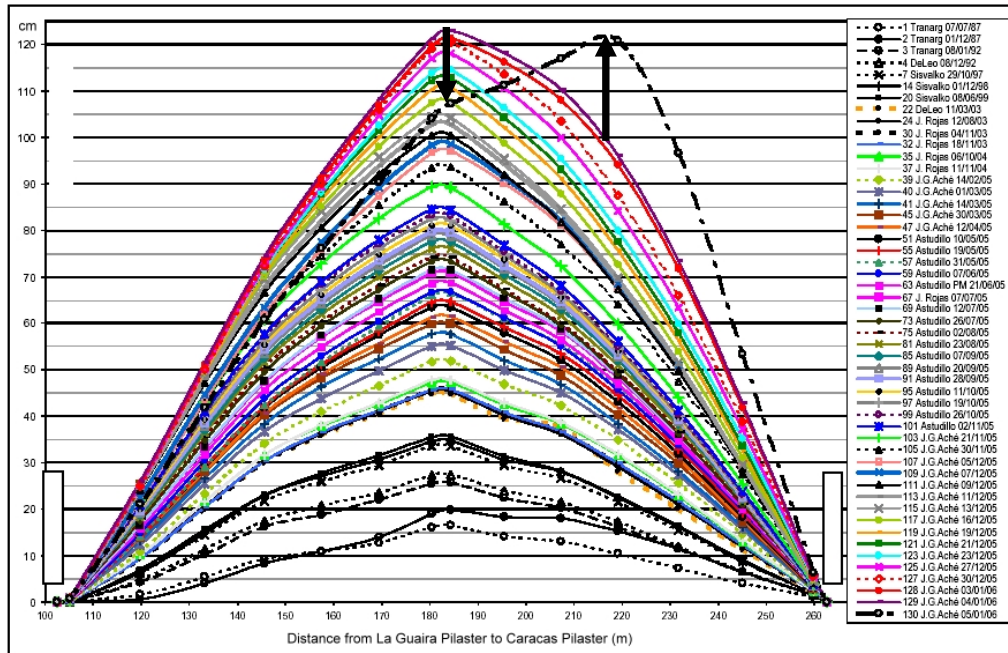
Figure 12. Vertical deformation of the deck before and after the January 5, 2006 event. Measurements between La Guaira Pilaster (left) and Caracas Pilaster (right) from June 7, 1987 to January 5, 2006. Note that the crown descended 17 cm and the broken section raised

- A significant change in the geometry of the arches (Figure 12). The maximum deformation originally at the crown changed to the section where rupture of the arches was observed. Also a transverse crack on the deck in the same section where the arches were broken, was also noticed

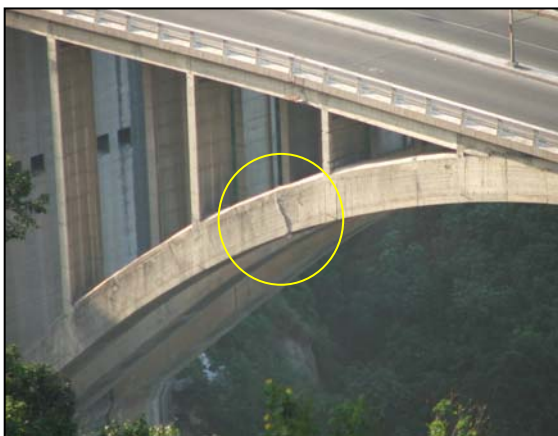
- Breakage of the three arches at a distance of 37 m measured from the crown towards the Caracas side. Crushing of concrete by compression at the fracture section was clearly observed inside and outside the arches.

Figure 13. Panoramic view of the East arch rupture. (January 5, 2006).

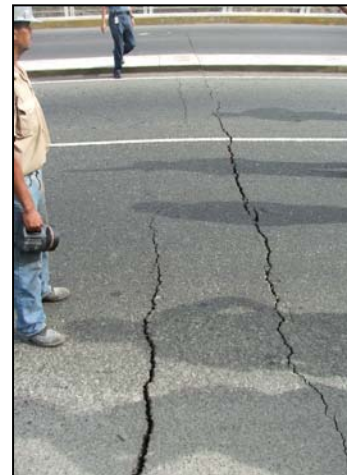
- Cracking and concrete crushing of the longitudinal beams that support the deck under the fracture section.
- Plastic deformations in the steel trusses that supported the deck in Piers 9' and 10'.

Figure 14. Cracking of the deck due to the January 5, 2006 event in the same structural section of the arch rupture. (January 5, 2006).

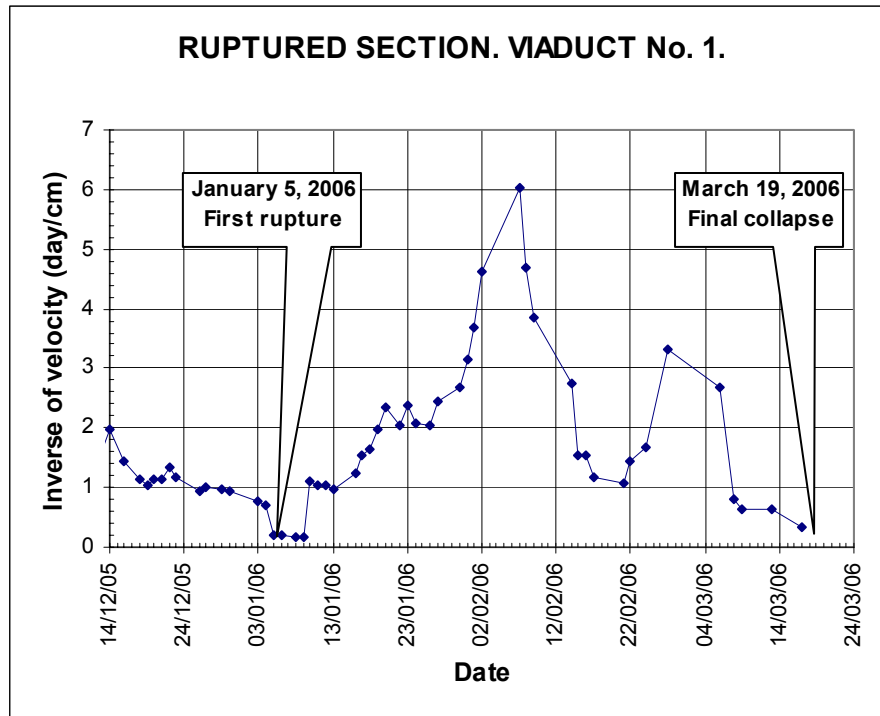
Figure 17. Inverse of velocity –vs– time. Measurements of two reference points installed on each side of the January 5, 2006 ruptured section.

Figure 17 graphically represents the inverse of velocity (day/cm) of the ruptured section that occurred in January 5, 2006, against time. It can be seen that fractures in the structure of the Viaduct No. 1 could have been approximately anticipated when readings were close to the x-axis.
